# Managing a peri-stoma allergy caused by the interaction of antibiotic treatment & a specific skin barrier contact

VALÉRIE MANIN, REGISTERED NURSE, ET, COMMUNITY NURSE, MARSEILLE, FRANCE

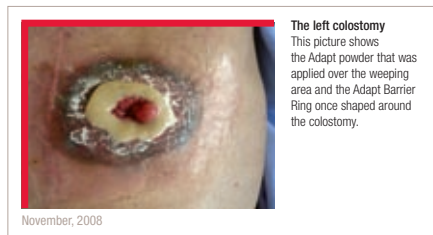
2 - Made with Flexend M technology, an Adapt Barrier Ring was shaped around the colostomy.
